Repairing the Spillway at Nathpa Jhakri Dam in India

Nathpa Jhakri is a concrete gravity dam on the Satluj River in Himachal Pradesh, India, about 500 km northwest of Delhi. The primary purpose of the dam, which was completed in 2004, is to impound a reservoir that supplies water for a 1,500-MW (2,000,000 hp) underground hydropower station.

By Les Faure

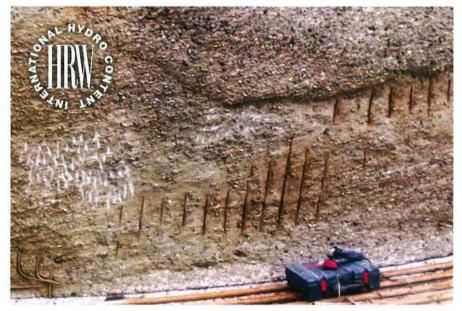
The spillway piers on the dam that impounds water for the 1,500-MW Nathpa Jhakri hydro project suffered extensive damage and erosion as a result of the high level of silt in the water and the rate of flow as it entered the powerhouse.

Civil structures also can suffer. Through the combination of the high velocity of the water and its high silt content, there was significant erosion of the concrete spillway piers of the dam. Since 2009, civil contractors were performing repairs, primarily reconcreting damaged portions on the spillway basin and piers, on a yearly basis to restore the surface profile.
