Reservoir Rehabilitation

The Jackson Gulch Reservoir, an imperative resource to the mountainous regions of southwestern Colorado, supplies water to more than 13,000 acres of agriculture lands as well as domestic water to Mesa Verde National Park. So when the concrete structure began to weaken, the Mancos Water Conservatory District hired Buckhorn Geotech Inc., Montrose, Colo., to evaluate the damage.

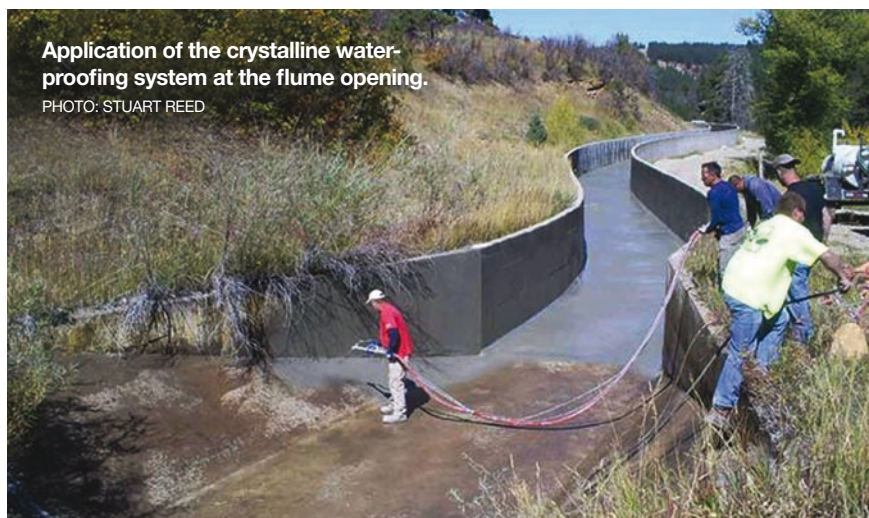
Application of the crystalline waterproofing system at the flume opening.

Then the flume was coated with Xypex Concentrate and modified using an Essex spray machine. The mixed material was pumped through 200-foot-long hoses to a nozzle that sprayed the flume’s concrete surfaces.

About 10,000 square feet of the waterproofing and protection was sprayed daily. “Our quality assurance team checked bag counts every day to make sure we were achieving proper coverage throughout the flume,” says Stuart Reed, estimator/project manager for Mays Construction.
