# Aging Concrete Flume Undergoes Crystalline Rehabilitation

First constructed in 1950, the Jackson Gulch Reservoir is a vital resource to resident and visitors of the high mountain regions of Southwestern Colorado. It supplies much-needed water to 13,746 acres of agricultural lands and domestic water to Mesa Verde National Park, Mancos Rural Water Company and the town of Mancos.

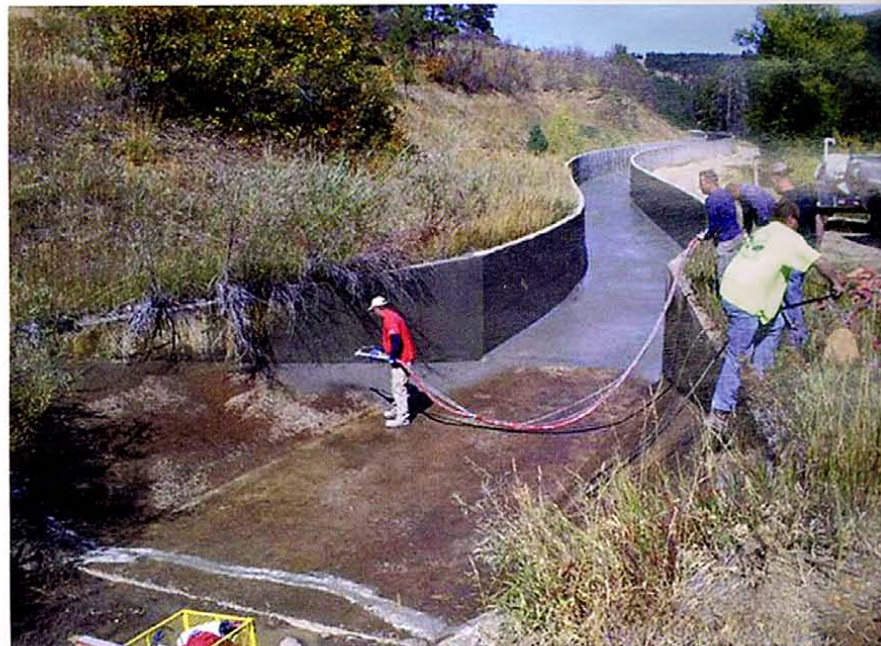
Application of Xypex Concentrate at flume opening.

Once they had cleaned and prepped the flume, the Mays Construction crews proceeded to coat the walls and floors with the Xypex Concentrate and Modified using an Essex spray machine. Crews pumped the mixed material through 200-foot hoses to a nozzle that sprayed the material onto the flume's concrete surface.

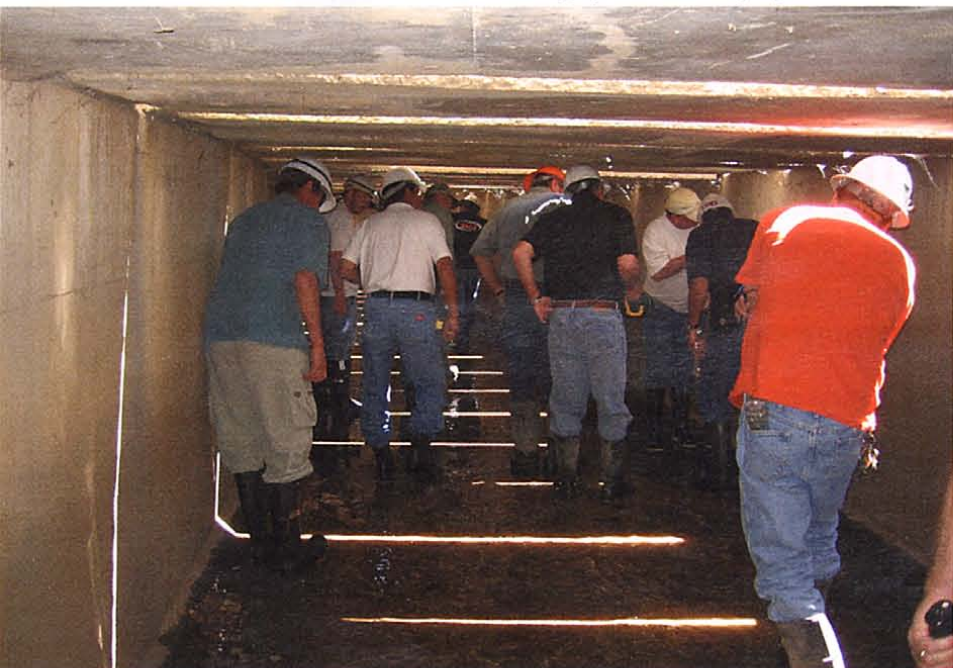
The project team inspected the flume to determine the scope of work required.

U-shaped concrete flume that was showing signs of serious deterioration ranging from surface spalling of the floor and joint deterioration to wall blowouts and vertical wall cracks.

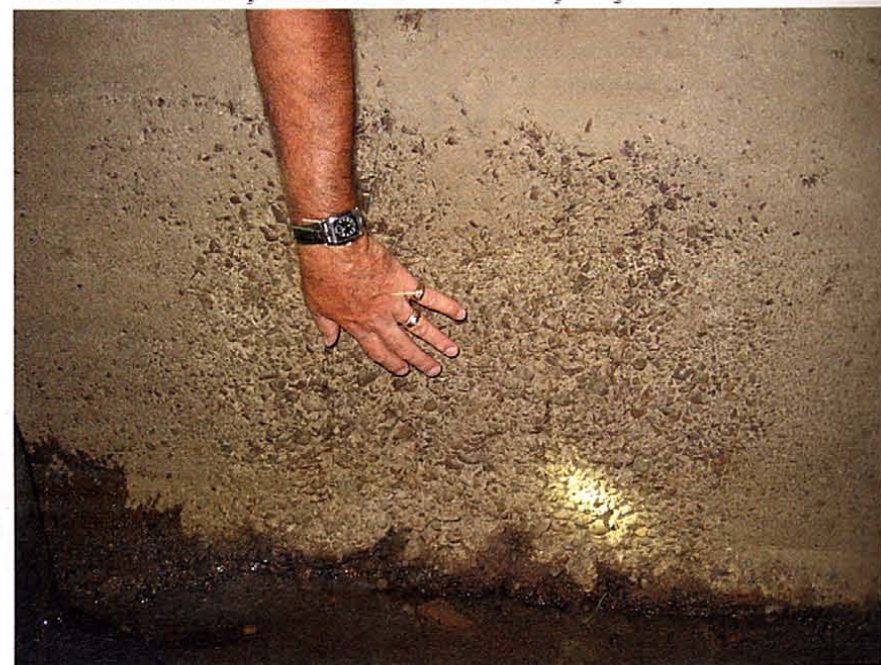
Deterioration included surface spalling, joint deterioration, wall blowouts and vertical wall cracks.

The Mays Construction crew used Xypex Megamix repair material to repair the blowouts of the control joints. The contractor relied on Xypex's Colorado representative, Stephen Boyd, throughout the clean and repair process to verify that the flume concrete was effectively prepared for the spray-on coating. Boyd also approved the crack and wall repairs and, ultimately, the coating preparation.
