Chishi Bridge

Yizhang County, China

Completion Date
2016

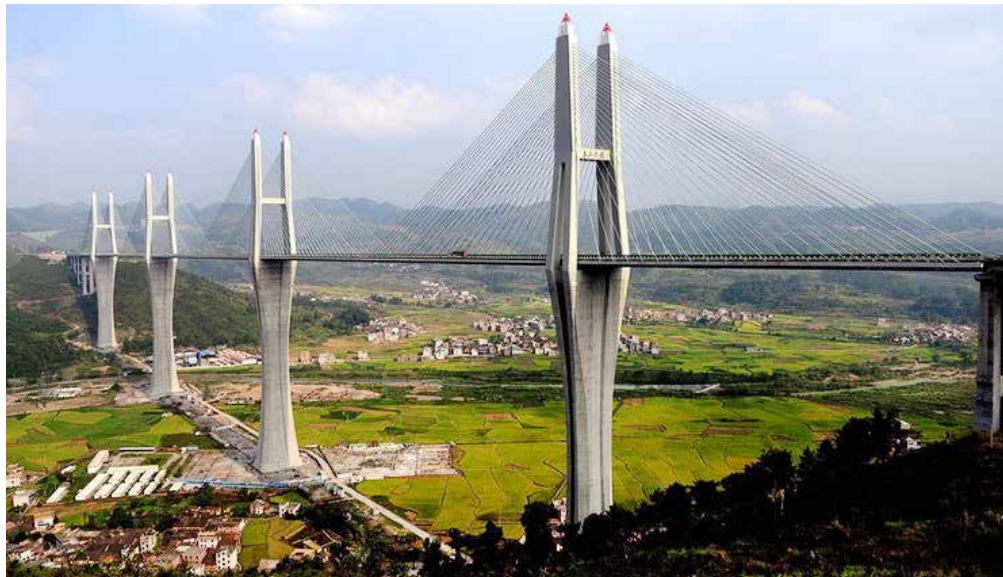
The location of the fire – within the hollow Pylon P6(S)

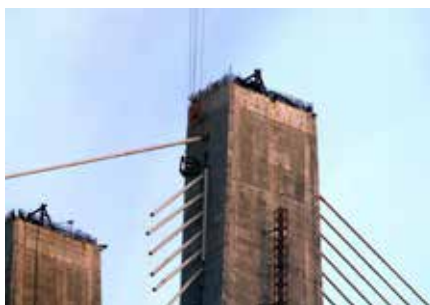
Nine of the twenty three cables supporting the bridge girder on the western side of Pylon P6 (S) broke as a result of the fire occurring inside the hollow pylon.

The bridge was in latter stages of completion when, on October 29th 2014, an accidental fire occurred during welding operations in the hollow pylon tower P6S (south) anchorage area,

resulting in nine of the twenty three suspension cables emerging from the west side of the pylon, being totally compromised during the approx. 85 minute fire event.

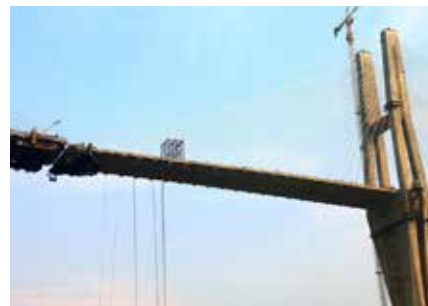
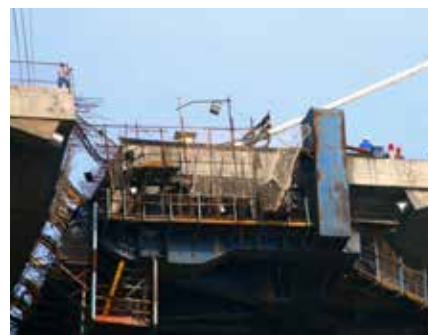
As the support cables broke, the cantilever end of the girder dropped by over 2.0 m on the south side, 0.8 m on the north side, with the twisting motion resulting in significant cracking of the girder and the bridge deck above it.

After the accident and as a result of failure of the nine cables, the west cantilever end of the girder – the same side that had been supported by the ruptured cables – moved downwards by 2.08 meters while at the other side, it moved 0.84 m downwards. Because of the urgency of the situation, engineers first installed and then ‘jacked’ nine temporary cables to stabilise the bridge girder then to return it as close as possible to its original, pre-fire position.

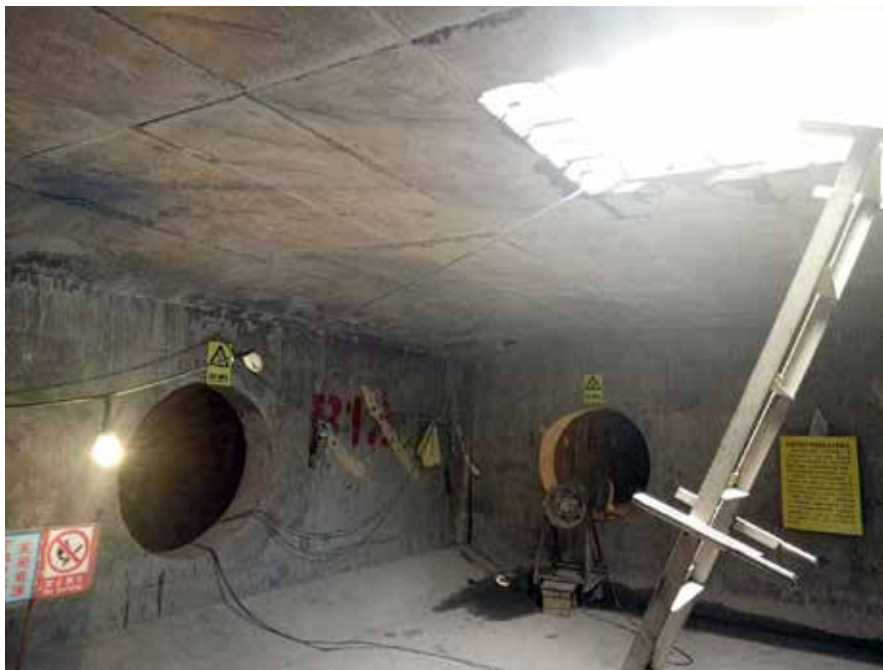
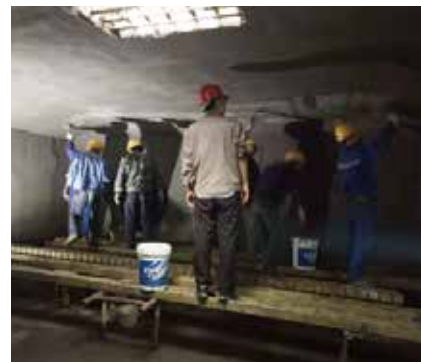
Almost 10,000 square meters of crack sealing and durability enhancing Xypex Concentrate treatment were applied at the direction of engineers of the Chishi Bridge recovery team.

Xypex applications thus began in April of 2016, with Xypex Concentrate being applied within the interior of the affected box girder, areas of the bridge deck, Pylon P6 and various related concrete components. Through strict process management and control during the treatment of approximately 10,000 square meters of internal and external surfaces, the application of Xypex proved a complete success, ensuring the 'healing' of a residual of cracks as well as the restoration of integrity and durability throughout the stress-impacted concretes.

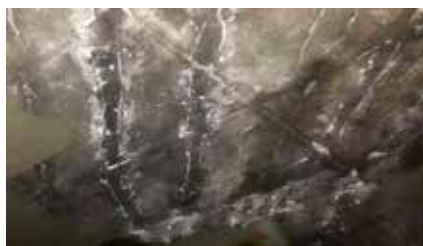
The failure of nine support cables as a result of the fire resulted in a dense distribution of diagonal cracks in the box girder and the top slab.

In his report ⁽¹⁾ Yu Zhang et al noted: "The results from the field inspection and simulation showed that (1) the obvious change in cable tension and concrete cracking occurred in only the remaining cables and part of the girder within and around the cable loss area; (2) the loss of nine cables in the local area caused the combined action of torsion and biaxial bending in the girder, and resulted in dense distribution of diagonal cracks in the top slab and box girder webs."
