Meeting the Challenge

Protecting Water Treatment Structures

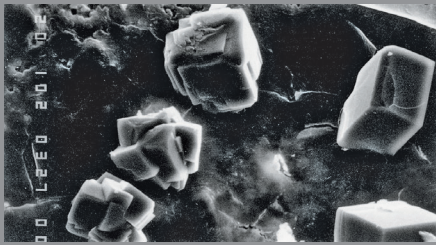
CONCRETE UNTREATED

Xypex products use the natural porosity of concrete and chemical diffusion to penetrate its pores and capillaries. Inside the concrete, Xypex chemicals react with the by-products of cement hydration to form a non-soluble crystalline structure deep within the substrate. In this condition, the concrete becomes impermeable, preventing the penetration of liquids and chemicals from any direction even under extreme hydrostatic pressure. The chemical resistant properties of the crystalline structure prevent the effects of attack by chemicals used in the treatment process.

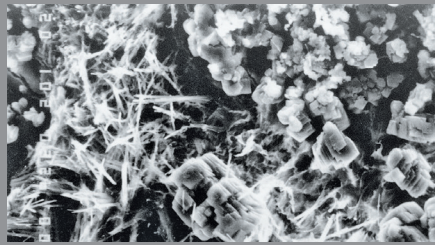
CRYSTALLIZATION INITIATED

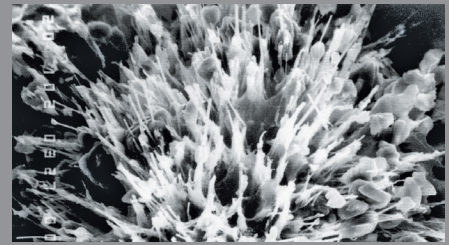
CRYSTALLIZATION MATURE
