**XYPEX**® The World Standard in Concrete Waterproofing by Crystallization

## XYPEX - THE CRYSTALLINE DIFFERENCE

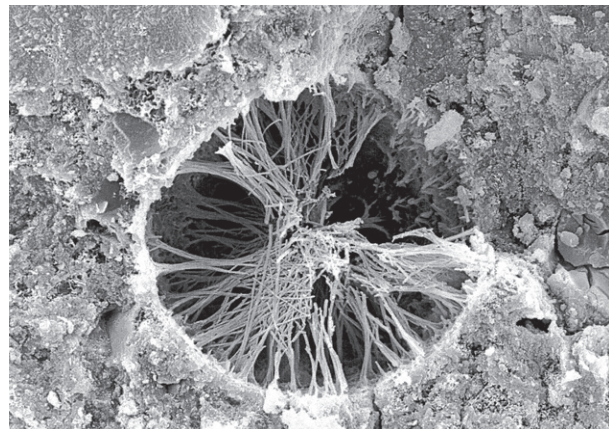
XYPEX TREATED CONCRETE

In the following pages, using the high-power imaging capability of a Scanning Electron Microscope (SEM), we display visual evidence that clearly differentiates Xypex from all other products in the waterproofing admixtures category. SEM is a technique whereby a precise photographic image of a microstructure is produced by scanning it with a focused beam of electrons. Extremely high degrees of magnification can be attained and, at x500 magnification, Xypex crystalline formations at work can be seen.

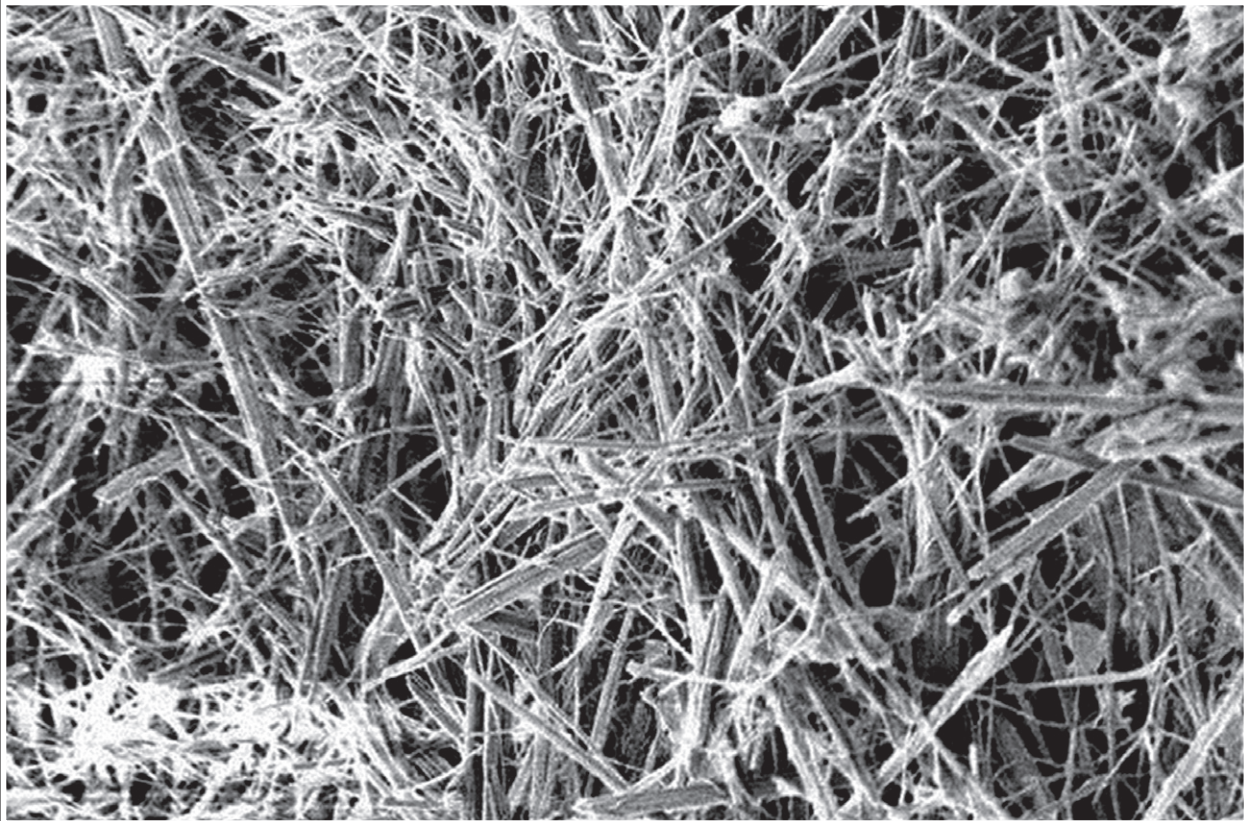
AUSINDUSTRY START GRADUATE PROGRAM  
SEM-105

As part of an extensive test program, samples were subject to water pressures equivalent to 100 m (330 ft.) of head. The 50 mm (2 in.) thick Xypex treated samples showed no signs of water penetration at this pressure, whereas the untreated control samples leaked even at 60 m (196 ft.) of water head. Below we see an SEM image of a Xypex treated sample at 2500x magnification. Note the dense mesh of Xypex crystals.

XYPEX TREATED CONCRETE

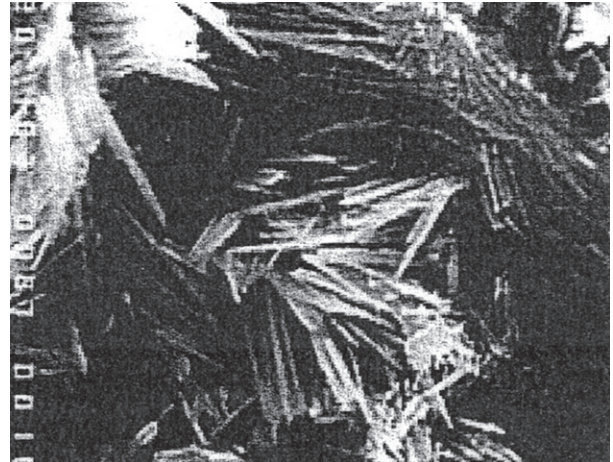
CIVIL ENGINEERING SOCIETY OF JAPAN  
SEM-102

XYPEX TREATED CONCRETE

The Hokutoh road-traffic bridge in Japan, constructed in 1972 suffered extensive cracking with widths of 0.1 – 0.2 mm allowing the penetration of water and de-icing salts. After treatment on the lower side of the bridge deck with Xypex Concentrate, cores were taken and subjected to 2 kg/cm<sup>2</sup> (29 psi) of pressurized water over time. Whereas the untreated areas continued to leak, all of the Xypex treated areas healed and leaking stopped.

In the SEM image, taken from concrete samples at 6 – 10 cm (2 – 4 in.) beneath the Xypex coated surface of the concrete, we can see how Xypex Crystalline Technology healed the cracks and stopped the leakage.

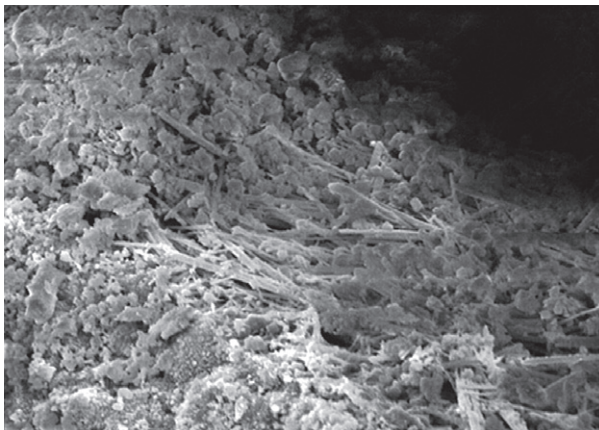
STREC – CHULALONGKORN UNIVERSITY THAILAND  
SEM-112

Experts investigated Xypex's crack-healing ability for cracks wider than 0.5 mm. In a sample taken from an in-service pre-cast element, the crack measured from 1.0 – 1.5 mm. From the x1000 imagery, taken at 28 days, it is evident that even in wider cracks Xypex crystals are forming.

XYPEX TREATED CONCRETE

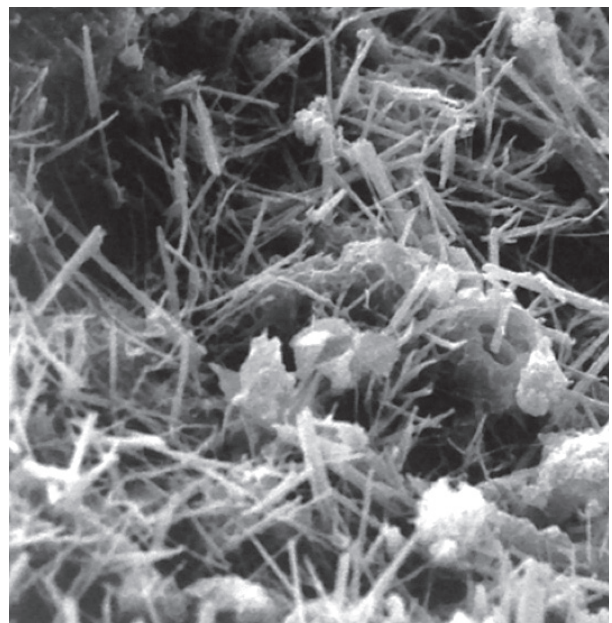
XAYABURI HYDROELECTRIC POWER PLANT, LAOS  
SEM-114

As part of the approval process, Xypex treated concrete was subjected to crack-healing testing. Concrete panels were cast, cracked by force and subjected to ponding of water over the cracks to measure the flow. The untreated control samples had cracks with an average width of 0.23 mm and continued to leak beyond the 25 day limit for the test. The Xypex treated panel had cracks with an average width of 0.38 mm and leakage through the cracks stopped after just four days. This was a site demonstration of the crack-healing abilities of Xypex and was subsequently captured in this SEM image.

XYPEX TREATED CONCRETE

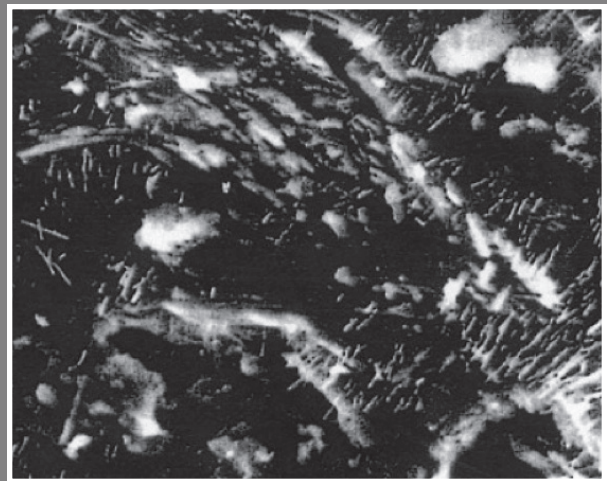
CIVIL ENGINEERING SOCIETY OF JAPAN  
SEM-100

In many repair situations it is impractical or too expensive to repair defective concrete on the positive side that is directly in contact with water.

Here, a sample of concrete coated with Xypex Concentrate on the negative side was left exposed to the environment for 12 months. SEM images were then taken of samples at different depths from the surface of the concrete. We can see evidence of crystalline growth at 300 mm (12 in.) from the surface of the concrete.

XYPEX TREATED CONCRETE

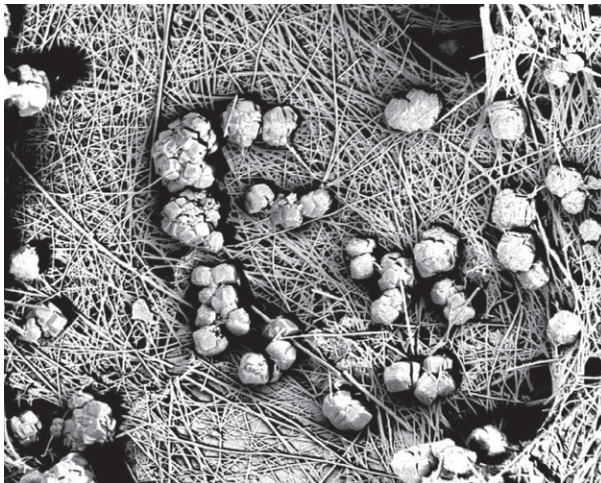
In this study, investigators wanted to understand how Xypex Admix reacts with supplementary cementitious materials (SCMs) such as blast furnace slag and fly ash. In this first image, taken at x2000 magnification, we can clearly see the Xypex Crystalline formation in a highly dense, 50 MPa (7,250 psi) compressive strength concrete containing a 60% slag blended cement.

XYPEX TREATED CONCRETE  
(60% SLAG BLENDED CEMENT)

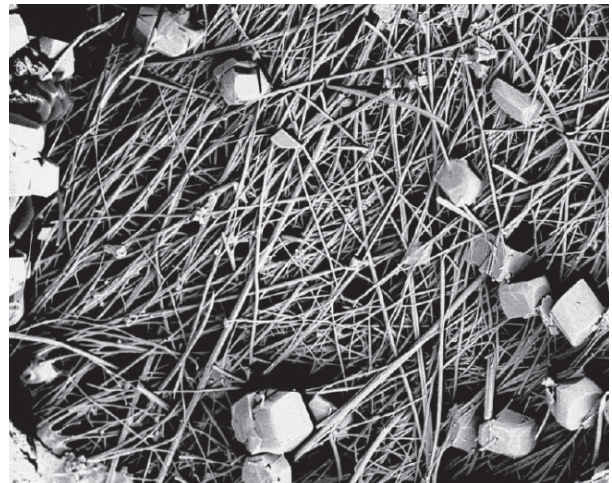
In this next image, again at x2000 magnification, we can see the Xypex Crystalline formation in a 65 MPa (9,425 psi) compressive strength concrete containing a 30% fly ash blended cement.

XYPEX TREATED CONCRETE  
(30% FLY ASH BLENDED CEMENT)

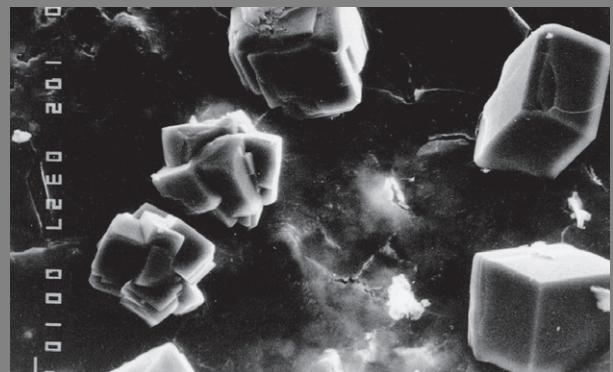
The essence of concrete durability is to protect the reinforcing steel of concrete from corrosion. Xypex achieves this by preventing the ingress of water and harmful chemicals. To assess the impact of Xypex on durability, investigators compared an untreated sample of concrete and a sample coated with Xypex Concentrate at a depth of 50 mm (2 in.), representing the standard cover depth of concrete over reinforcing steel.

In the untreated image we can see precipitated calcium hydroxide particles and no crystalline growth. In the sample treated with Xypex Concentrate, we can see that at 50 mm (2 in.), an extensive crystalline formation has taken place, affording complete protection for the embedded reinforcing steel.

UNTREATED CONCRETE AT 50 MM

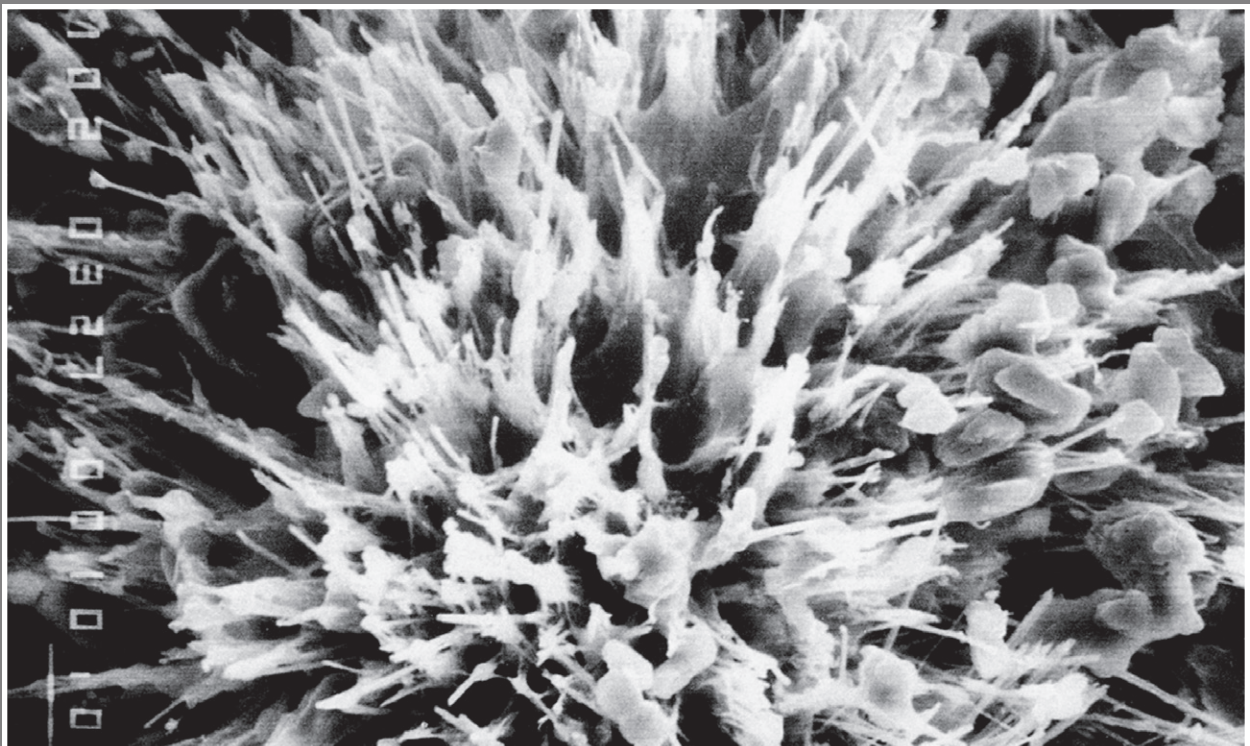
XYPEX CONCENTRATE AT 50 MM

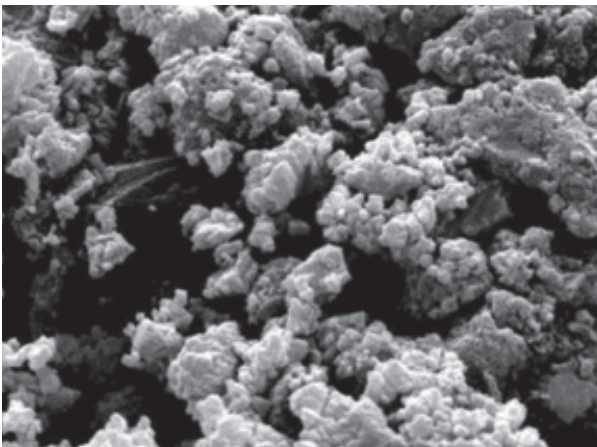
UNTREATED CONCRETE

Xypex was chosen to protect and waterproof the 1.5 m (5 ft.) thick upstream face of this 108 m (354 ft.) high, 704.5 m (2,311 ft.) wide, gravity dam constructed with roller-compacted concrete. Prior to selection, concrete samples were produced on site using exactly the same materials used in the production of the construction concrete. They were then subjected to rigorous testing, at all times comparing the performance of untreated samples with those treated with Xypex.

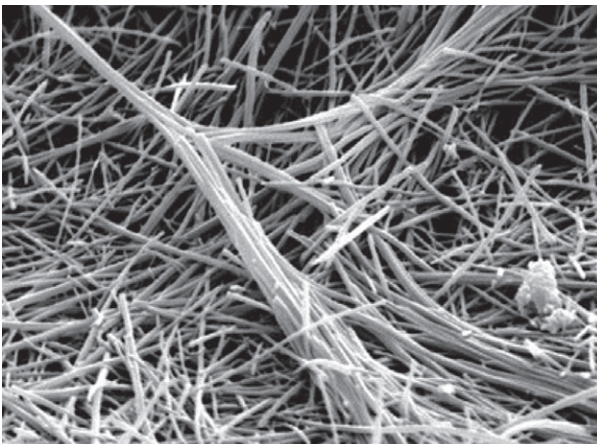
XYPEX TREATED CONCRETE

The SEM investigation of the same samples clearly illustrated the dense, crystalline structures formed within the Xypex treated concrete matrix, giving 100% protection to the face of the dam.

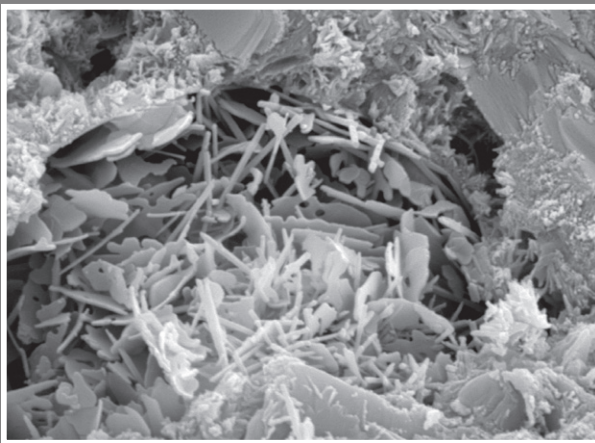
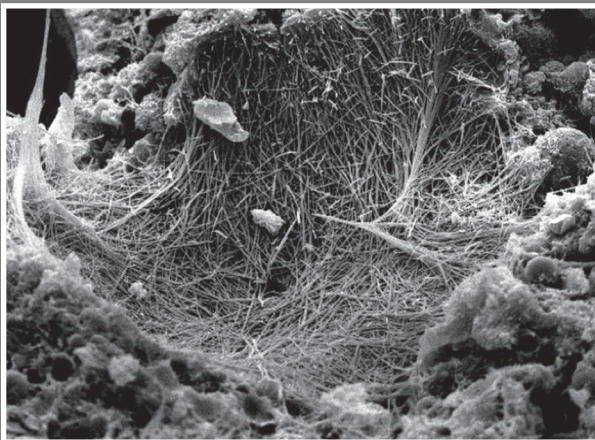
ELECTRICITY GENERATING AUTHORITY  
OF THAILAND, RATCHABURI POWER STATION  
SEM-113

XYPEX TREATED CONCRETE

The Ratchaburi Power Station is located on the estuary of the Mae Klong River and is exposed to destructive chloride attack. Xypex Concentrate and Modified were used to treat the 4-year-old roof decks of the cooling towers. Concrete cores extracted from the cooling towers were subjected to microscopic examination. In the SEM image taken at x7000 magnification and a depth of 20 mm, we see the developing crystalline formation interwoven with flat plate-like structures similar to calcium hydroxide. This formation protects the reinforcing steel from harmful effects of chloride attack.
