# Protecting Precast Sewage Structures with Crystalline Technology

By Jim Caruth

Technical Services Manager  
Xypex Chemical Corporation

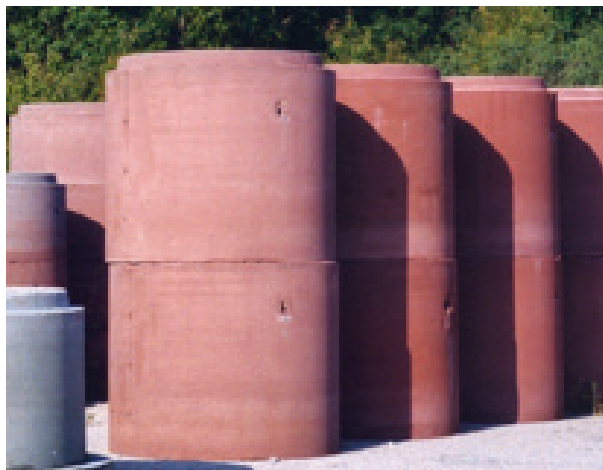
*Precast concrete manholes manufactured with crystalline technology incorporating red pigment for easier identification.*

Crystalline materials are available in powder form that can either be incorporated into a concrete mix for new structures or mixed with water into a slurry consistency for brush or spray application on the surface of existing concrete structures.

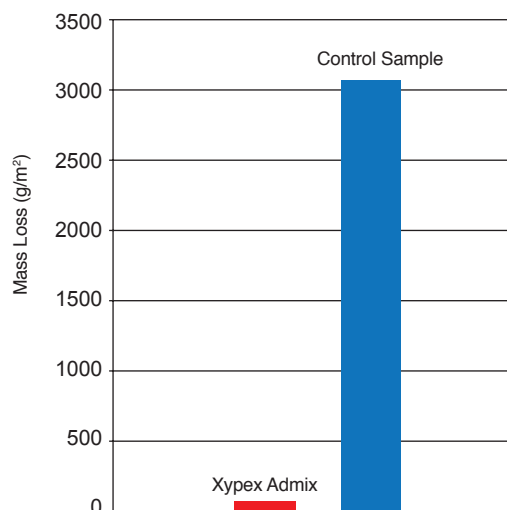
#### Sulfate Resistance Test (60 d @ 36000 mg/L SO<sub>4</sub>)

*Accelerated sulfate corrosion test results.*

In accelerated sulfate corrosion testing, 150 mm cubes cast with C30/37 classified concrete (4,500 PSI) were exposed to a highly concentrated sulfate solution (36,000 mg/l) for 60 days. Following exposure, all samples were weighed and examined for surface deterioration. The samples formulated with Xypex Admix C-1000 NF had a weight loss of between 38.6 - 90.5 g/m<sup>2</sup> and visual examination showed only minor deterioration at the edges. Control samples had a mass loss between 2,473.0 and 3,693 g/m<sup>2</sup> and visual examination showed significant surface deterioration over the entire surface of the cubes. Based on this testing, there is convincing evidence of Xypex Crystalline Technology's effectiveness in providing a marked increase in resistance when exposed to difficult sulfate conditions.

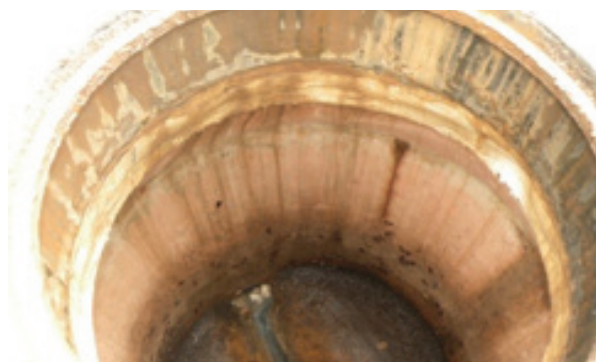
*Terrebonne Parish manholes with crystalline admix show little deterioration after 10 years of service.*

Xypex Admix C-1000 Red was utilized in the manufacture of approximately 30 precast manholes in 1999 for the Clinton Street Sewer Collection Project in Terrebonne Parish, Louisiana. Xypex Admix was specified for waterproofing and provide chemical protection against degradation of concrete surfaces exposed to acid and sulfate attack. Xypex Admix with a red pigment was used for easy identification and verification of manholes treated with Xypex Admix. The manholes were inspected in August 2010 and found to be in excellent condition showing no signs of deterioration whatsoever after more than 10 years of exposure.
