## BIO-SAN®C500

Antimicrobial Crystalline Technology

For protection of concrete in severe sewage conditions

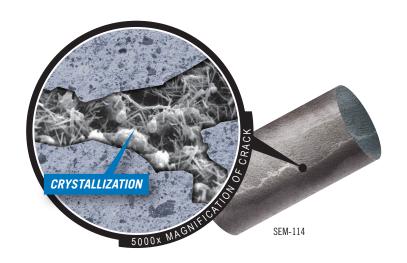
#### Self-heals cracks up to 0.5 mm

Concrete panels were cast and then cracked by force after which they were subjected to the ponding of water to measure the flow through the crack. After four days the 0.38 mm crack on the Xypex treated sample had stopped leaking completely. The 0.25 mm crack in the control sample continued to leak after 25 days.

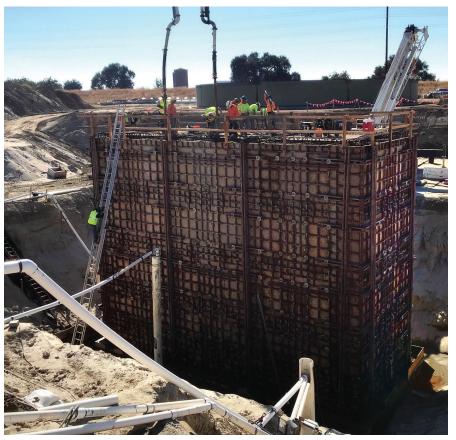
**River Island Sewage Pump Station, California, USA** Pump/Lift Station • Xypex Bio-San C500
